# NSPIRE for Public Housing PowerPoints

Day 3

September 2023

Nan McKay & Associates, Inc.

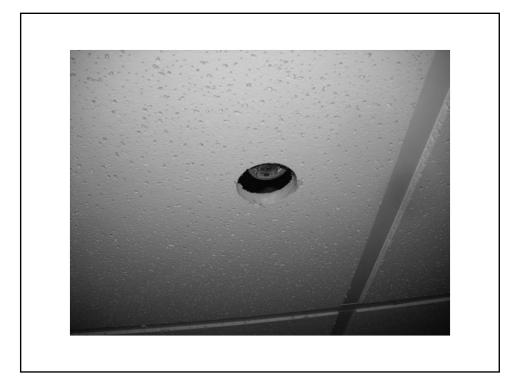
Sprinkler assembly has evidence of foreign material that is detrimental to performance
